# HALT Evaluation of SJ BIST Technology for Electronic Prognostics

**Abstract**—This paper presents the design, test, and results of a highly accelerated life test (HALT) evaluation of a soft-core called Solder Joint Built-in Self-Test™ (SJ BIST™), a method for detecting faults caused by solder-joint fractures in monitored input/output (I/O) pins of field programmable gate array (FPGA) devices, especially those in ball grid array (BGA) type of packages. Modern electronics utilize large FPGAs packages attached to electronic boards by means of solder joints, such as solder balls, between the package and the board. Thermo-mechanical stresses – primarily heat and vibration – cause fatigue damage and eventual fracture failure of one or more balls, which causes intermittent operational faults leading to catastrophic failures in critical systems. Such intermittent faults are difficult to reproduce on a test bench and many field returns of electronic modules with intermittently failing solder balls are diagnosed with code "no trouble found/could not reproduce." The SJ BIST soft-core offers a solution because it detects faults in monitored pins caused by fractured solder joints of programm

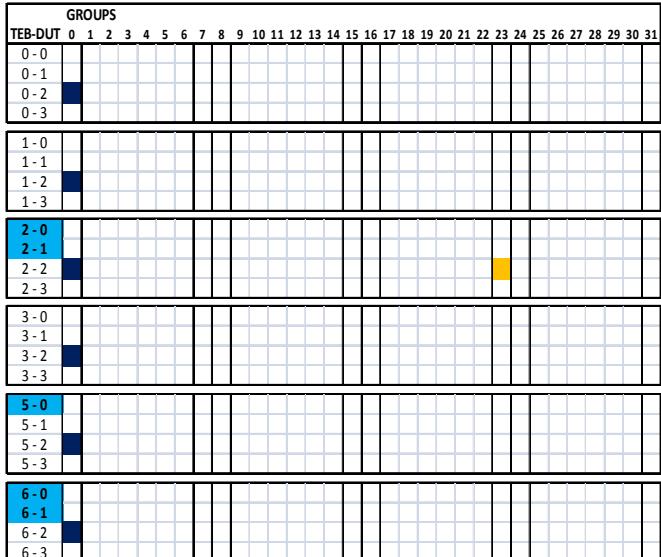
Figure 10. HALT status for cycle 4.

Five of the 24 FPGAs were found to be nonresponsive prior to starting the HALT: Board 2, FPGAs 0 and 1; board 5, FPGA 0; and board 6, FPGAs 0 and 1. Because of time and budget constraints, we elected to not fabricate replacement boards. The logged data for HALT cycle 4 (HC4) confirmed the null responses from those FPGAs.

In addition to reporting a null response from FPGA 0 and 1, the data log (see Fig. 9) for board 2 showed pin group 0 of FPGA 2 had a hard error on both pins. This same error occurred on FPGA 2 on all boards. The data log also indicated that both pins in group 23 of that FPGA were open: subsequent cycles indicated that group experienced intermittent faults. The

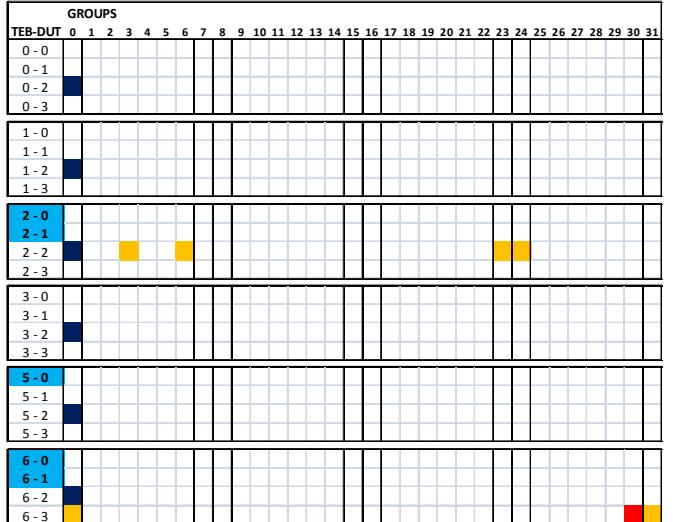
Figure 11. HALT status for cycle 23.

Continuous HALT cycling began 16 November and on 20 November the logged data for cycles 5 through 23 were sent to Tucson for analysis to verify the firmware and software to collect and log data were working correctly. Fig. 11 shows intermittent faults occurring in six additional pin groups.

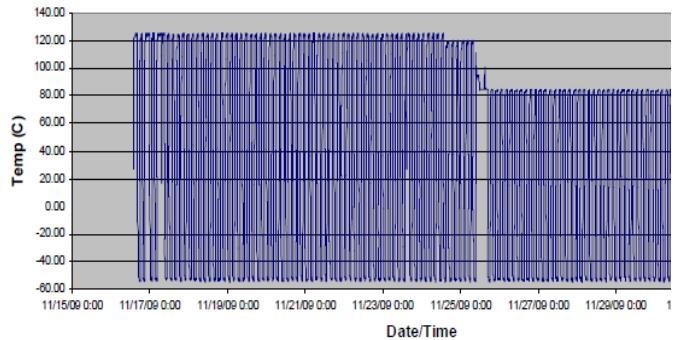
Figure 12. Partial profile of the chamber temperature.

On 25 November, it was noticed the 5A 5VDC power supply was going into current-limiting mode. We decided to reduce the oven temperature to 85°C (see Fig. 12) until we could replace the original with a larger power supply. When we examined the logged data records, and we determined the

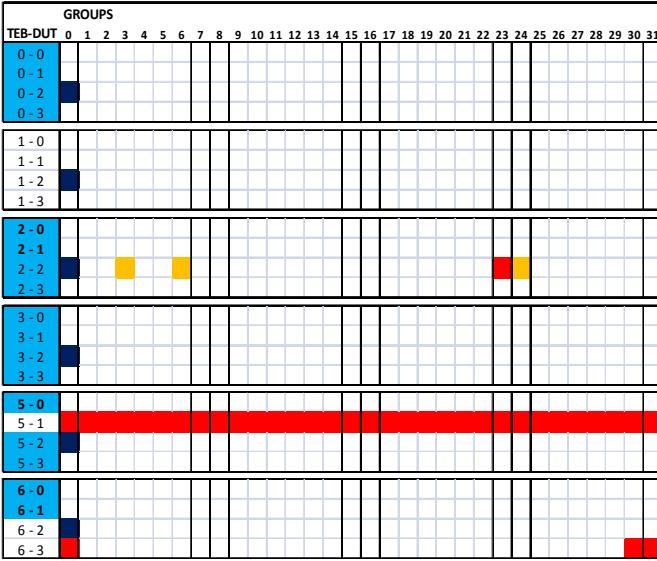
Figure 13. HALT status at end of cycle 72 (30 November).

previous damage to boards 2 and 6 had increased as shown in Table III, Table IV, and Fig. 13:

HC 72		Logged Record
1	Board 1 and 6: no change	
2	Board 5: FPGA 0, 2, and 3	NULL FPGA RESPONSE
3	Board 5: FPGA 1 - all pins broken (suspicious)	050100050FOFOFOF
4	Board 0, 2, and 3	NO SIGNAL

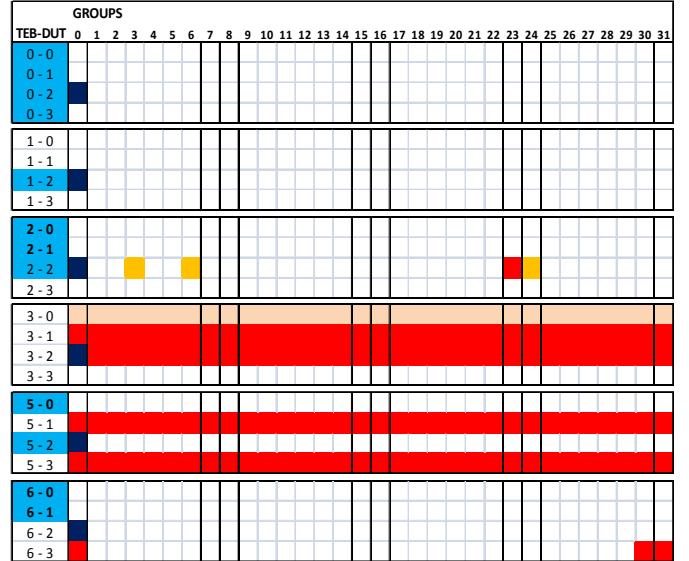
Figure 14. HALT status at end of cycle 204 (13 January 2010).

The logged data records ending 13 January were sent to Tucson for examination: nine new error and fault conditions were noted as shown in Table V and Fig 14. The team in Tucson asked the team in Johnson City to examine the cables: the RS-232 cables exhibited high-heat damage to include brittle and broken insulation, and interior material liquefied and oozing (see Fig. 15). The HALT was again suspended on 29 January pending replacement of the RS-232 cables. Board 0 was returned to Tucson for physical examination: there was no visible sign of damage.

HC 204		Logged Records
1	Board 0, no response from the controller	missing all records
2	Board 1, FPGA 2 stopped responding	NULL FPGA RESPONSE: 2
3	Intermittent power off-on	0103200505050505 POWER ON: 0103210505050505
4	Board 2, FPGA 2 stopped responding	NULL FPGA RESPONSE: 2
5	Board 3, FPGA 0, bad dummy record instead of 0300020050505050	0300200000000000
6	Board 3, FPGA 1 through 3, high fault counts	for example: 248 and 208 faults 030100050F080D08 149 and 172 faults 0301010509050A0C 32 and 38 faults 0301020502000206
7	Board 5, FPGA 1, moderate counts: 25 and 39 16 and 14 2 and 4	0501000501090207 050101050100000E 0501020500020004
8	Board 5: FPGA 2 stopped responding	NULL FPGA RESPONSE: 2
9	Board 5: FPGA 3, fairly high counts: 160 and 4 161 and 7 14 and 3	0503000501000004 0503010501010007 05030205000E0003

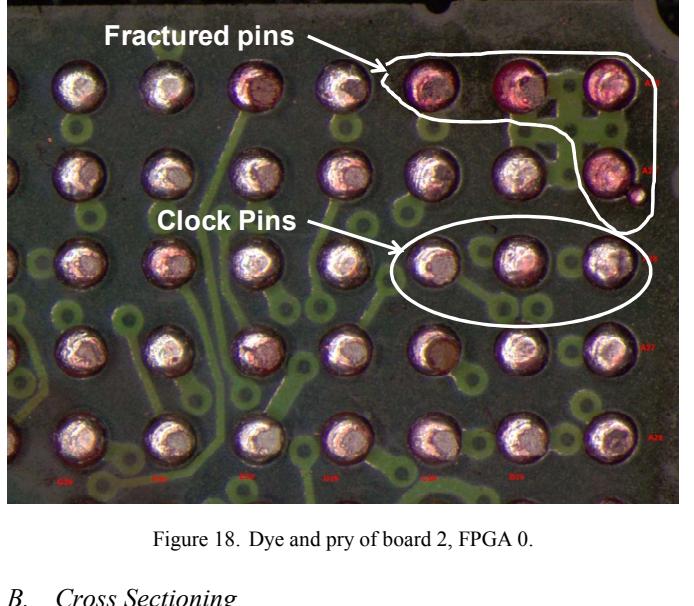
Figure 18. Dye and pry of board 2, FPGA 0.

For the dye and pry examination (37 images), we selected board 2, FPGA 0, which was reported as null response from the very start of the HALT. Fig. 18 shows the one of the corners (A30) and clearly shows a failed pin next to the four corner (ground) pins, and three of the four ground pins fractured. At all four corners, there was at least one ball next to the corner that was fractured.

Looking at the middle clock pin shown in Fig. 18, the appearance of the ball indicates it was not securely attached to the board land – there is a lack of solder damage from the pry.

This might have caused a loss of the clock, which might explain the non-responsiveness of that FPGA.

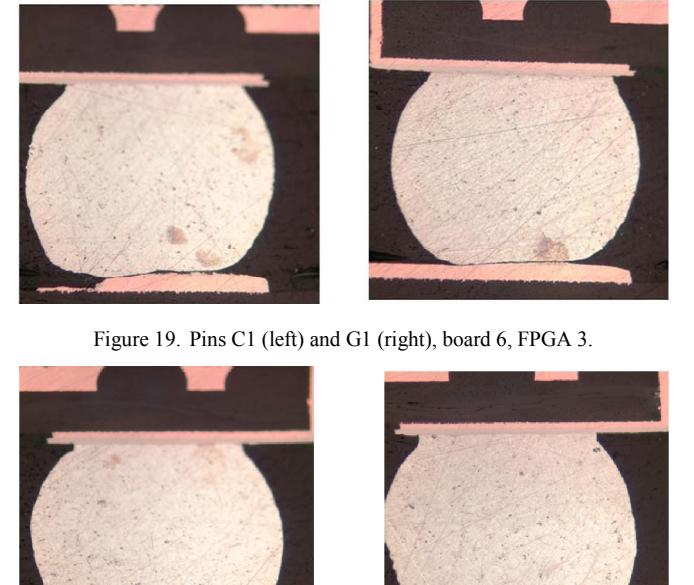
Figure 19. Pins C1 (left) and G1 (right), board 6, FPGA 3.

We cross sectioned 48 pins and examined 103 images. We concluded the following: pins that SJ BIST reported as having faults were fractured (no false alarms), an example of two pins C1 from group 31, board 6, FPGA 3 and G1 from group 30, board 6, FPGA 3 are shown in Fig. 19. Both balls are fractured, and referring to Fig. 17, SJ BIST detected high number of faults. With one possible exception (see Fig. 21), no fractures were found in pins SJ BIST reported as healthy. Fig. 20 shows two pins monitored by SJ BIST and for which no faults were reported: those pins were not fractured.

This apparent fracturing with no detectable occurrence of faults is an example of the intermittent nature of solder-joint caused faults. Another example is cycle 54: SJ BIST reported the occurrence of only two faults each for board 6, FPGA 3, group 31, pins C1 (which Fig. 19 shows is clearly fractured)

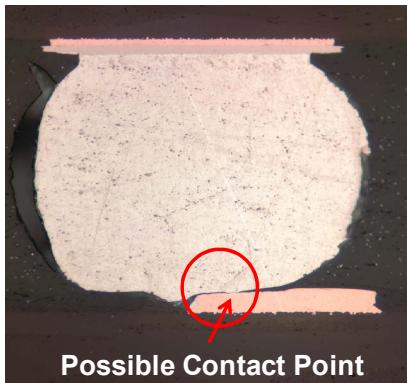
Figure 21. Fault not detected:board 6, FPGA 3, pin A24.

In addition to the possible contact point shown in Fig. 21, a fault might not occur for any number of other reasons: (1) The cross sectioning might have hidden a partial contact point (see Fig. 22); (2) Vibration stresses might not have caused the fractured surfaces to open: conformal coating might dampen the effect of a vertical strain on device; and (3) The fault duration might be too short: the minimum fault duration is one-half of a clock cycle (20ns for this HALT). Guaranteed fault detection requires the fault to last at least 2 clock periods (80ns) and have an effective open resistance of  $100\Omega$  or more.
