# Ball Grid Array (BGA) Solder Joint Intermittency Detection: SJ BIST

*Abstract*—This paper presents test results and specifications for SJ BIST™, an innovative sensing method for detecting faults in solder-joint networks that belong to the I/O ports of Field Programmable Gate Arrays (FPGAs), especially in Ball Grid Array packages. It is well-known that fractured solder joints typically maintain sufficient electrical contact to operate correctly for long periods of time. Subsequently the damaged joint begins to exhibit intermittent failures: the faces of a fracture separate during periods of stress, causing incorrect FPGA signals. SJ BIST detects faults of 100  $\Omega$  or lower with zero false alarms: minimum detectable fault period is one-half the period of the FPGA clock; guaranteed detection is two clock periods. Being able to detect solder joint faults in FPGAs increases fault coverage and health management capabilities, and provides support for condition-based and reliability-centered maintenance<sup>12</sup>.

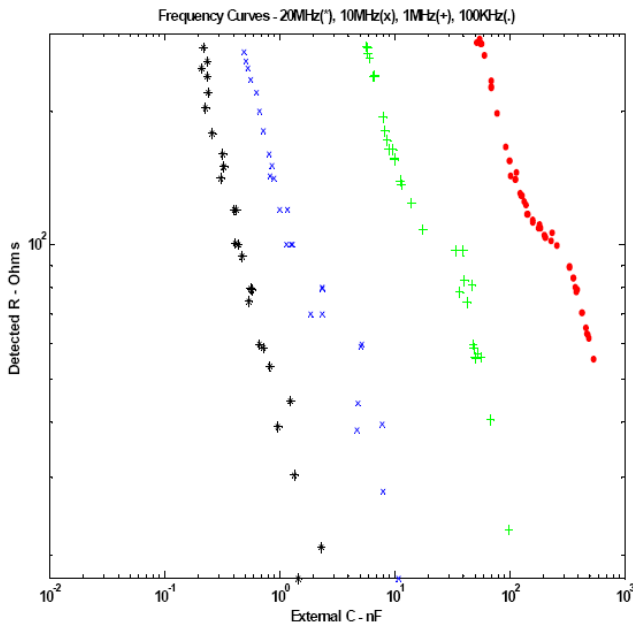
Figure 14: Frequency, Capacitor and Resistance.

The relationship between the frequency of the FPGA clock, the value of the connected capacitor to each group of two I/O pins, and the detectable fault resistance is shown in Figure 14.

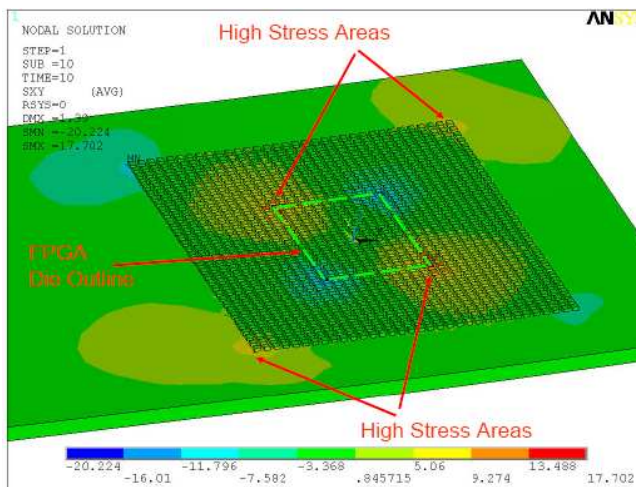
Figure 16: FG1156 Strain Diagram.

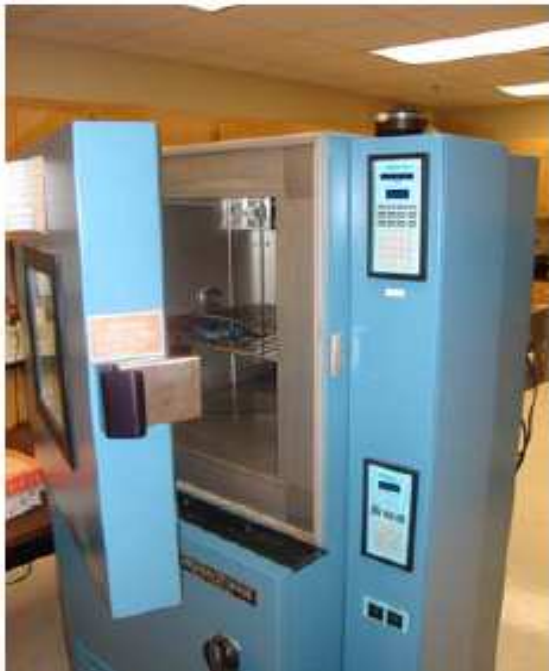
**Figure 19: Thermal Oven for Solder Joint HALT Testing – CAVE, Auburn University, Alabama.**

At the Center for Advanced Vehicle Electronics at Auburn University, Alabama, test boards are placed in a thermal oven (Figure 19) and cycled from  $-55\text{ }^{\circ}\text{C}$  to  $125\text{ }^{\circ}\text{C}$  in 30 minute ramps and 15 minute dwells. The boards are subjected random cyclic shock with variable frequency superimposed with random vibrations (Figure 20). A drop test is performed and the test board is placed in the oven for 5 days. Data is collected at the beginning of the test and then twice a day. At the end of 5 days, another drop test is performed with data collected before and after the drop test. This procedure is repeated for each test board until the boards are damaged.

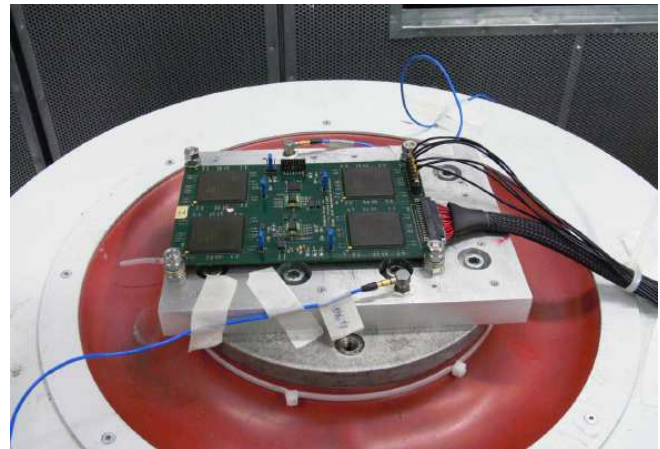
**Figure 20: HALT Test Board Mounted on Vibrator.**

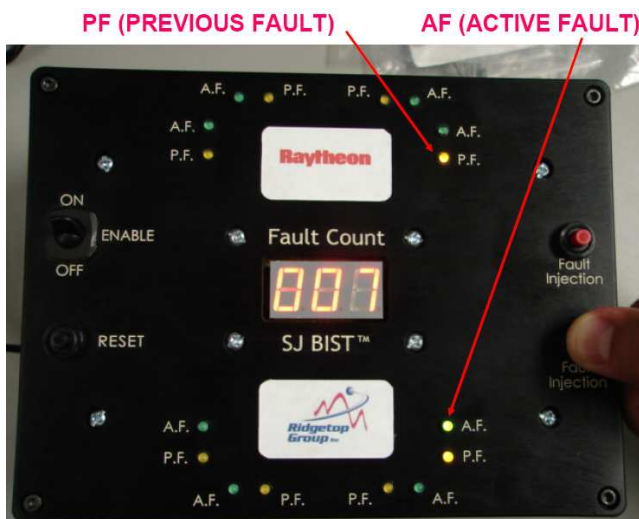
Figure 23: SJ BIST Demonstration Box.

Figure 23 is a picture of one of the SJ BIST demonstration boxes being tested for delivery to Raytheon Missile Systems. The front panel shows a fault count of 7, a previously detected fault in an upper-right pin, and both an active (the fault inject button is depressed) and a previously detected fault in a lower-right pin. The purpose of the box is to allow for portable demonstrations, and to allow non-Ridgetop personnel to independently demonstrate and evaluate SJ BIST.
