Ball Grid Array (BGA) Solder Joint Intermittency Detection: SJ BIST™

Abstract—This paper presents test results and specifications for SJ BIST™, an innovative sensing method for detecting faults in solder-joint networks that belong to the I/O ports of Field Programmable Gate Arrays (FPGAs), especially in Ball Grid Array packages. It is well-known that fractured solder joints typically maintain sufficient electrical contact to operate correctly for long periods of time. Subsequently the damaged joint begins to exhibit intermittent failures: the faces of a fracture separate during periods of stress, causing incorrect FPGA signals. SJ BIST detects faults of 100 Ω or lower with zero false alarms: minimum detectable fault period is one-half the period of the FPGA clock; guaranteed detection is two clock periods. Being able to detect solder joint faults in FPGAs increases fault coverage and health management capabilities, and provides support for condition-based and reliability-centered maintenance¹².

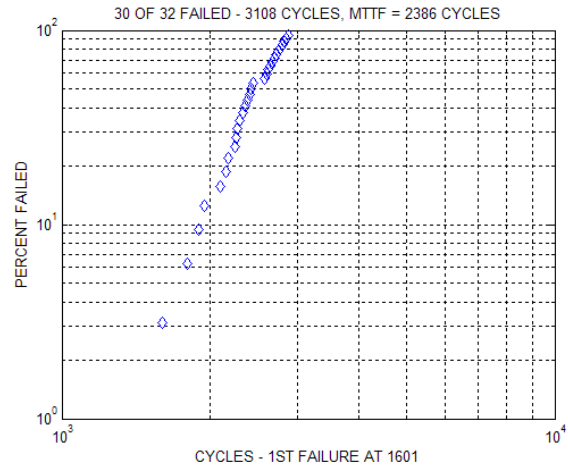
Figure 8: XILINX FPGA HALT Test Results [15].

Figure 8 represents HALT test results performed on XILINX FG1156 Daisy Chain packages in which 30 out of 32 tested packages failed in a test period consisting of 3108 HALT cycles. Each temperature cycle of the HALT was a transition from -55°C to 125 °C in 30 minutes: 3-minute ramps and 12-minute dwells. What is not immediately apparent is that each of the logged FPGA failures (diamond symbols) represents at least 30 events of high resistance: a FAIL was defined as being at least 2 OPENS within the same temperature cycle. A single OPEN in any temperature cycle was not counted as a FAIL event; and the package was deemed as failed only after 15 FAILS [15] had been logged.

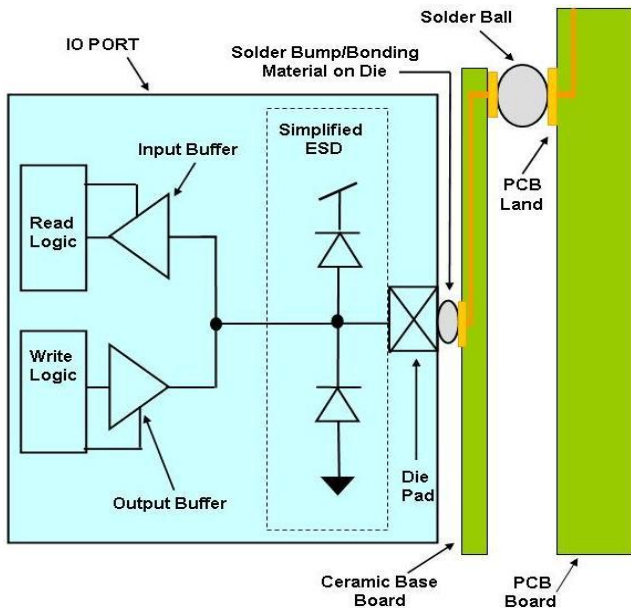
Figure 9: FPGA Diagram, I/O Buffer [22].

FPGAs are not amenable to the measurement techniques typically used in manufacturing reliability tests such as Highly Accelerated Life Tests (HALTs) [10]. This is because, for example, a 4-point probe measurement requires devices to be powered-off; and because FPGA I/O ports are digital, rather than analog, circuits (see Figure 9).

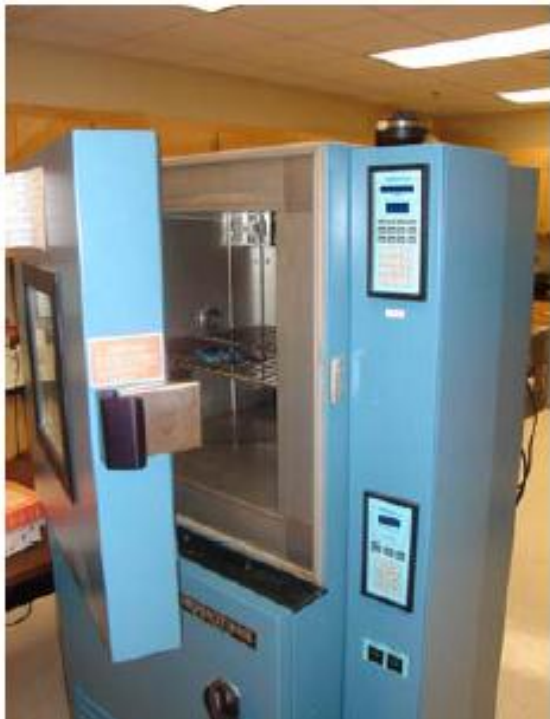
Figure 18: Thermal Oven for Solder Joint HALT Testing – CAVE, Auburn University, Alabama.

At the Center for Advanced Vehicle Electronics at Auburn University, Alabama, test boards are placed in a thermal oven (Figure 18) and cycled from -55 °C to 125 °C in 30 minute ramps and 15 minute dwells. The boards are subjected random cyclic shock with variable frequency superimposed with random vibrations. A drop test is performed and the test board is placed in the oven for 5 days. Data is collected at the beginning of the test and then twice a day. At the end of 5 days, another drop test is performed with data collected before and after the drop test. This procedure is repeated for each test board until the boards are damaged.

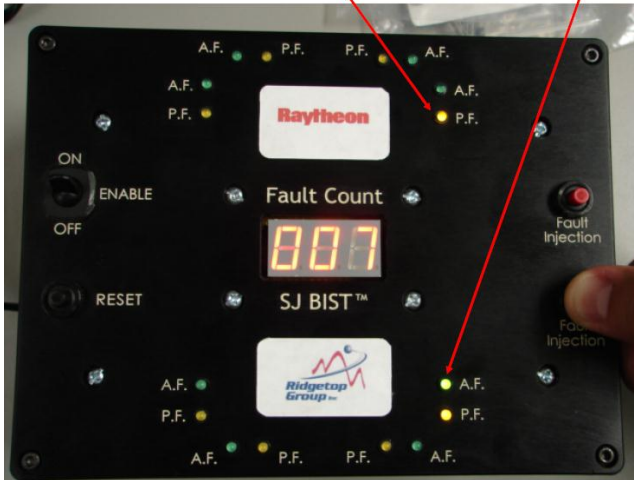
Figure 21: SJ BIST Demonstration Box.

Figure 21 is a picture of one of the SJ BIST demonstration boxes being tested for delivery to Raytheon Missile Systems. The front panel shows a fault count of 7, a previously detected fault in an upper-right pin, and both an active (the fault inject button is depressed) and a previously detected fault in a lower-right pin. The purpose of the box is to allow for portable demonstrations, and to allow non-Ridgetop personnel to independently demonstrate and evaluate SJ BIST.
