High Density FPGA Package BIST Technique

Douglas Goodman, James Hofmeister, Justin Judkins, PhD Ridgetop Group Inc. 3580 West Ina Road Tucson, AZ 85741 (520) 742-3300 Doug@ridgetop-group.com

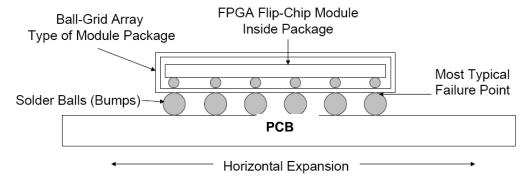
Figure 3: BGA Solder-Joint, Solder Balls and Typical Failure Point.

The most typical failure point is the junction between the FPGA package and the solder ball as depicted in **Figure 3**.

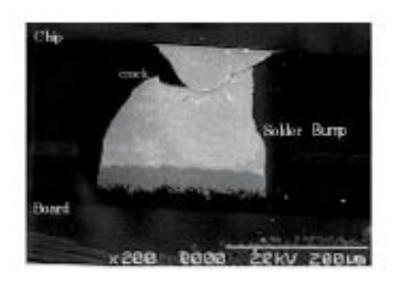
Figure 4 – Solder bump cracking (from Auburn University)

A typical failed joint using results from Auburn University is shown in figure 4.

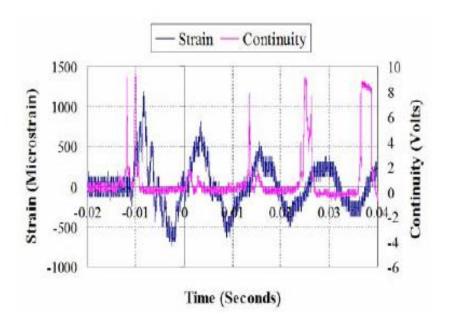
Figure 9 – Measurement results showing applied strain and intermittent continuity through the solder ball.

Actual measurement results taken are shown in figure 9.
