IN-SITU, REAL-TIME DETECTOR FOR FAULTS IN SOLDER JOINT NETWORKS BELONGING TO OPERATIONAL, FULLY PROGRAMMED FIELD PROGRAMMABLE GATE ARRAYS (FPGAS)

Abstract - In this paper we introduce an in-situ solder-joint built-in self-test (SJ BIST) for detecting high-resistance faults in operational, fully-programmed field programmable gate arrays (FPGAs). The approach is simple to implement, offers a method to detect high-resistance faults that result from damaged solder-joints, and uses a maximum of one small capacitor externally-connected to each selected test pin or each group of two test pins.

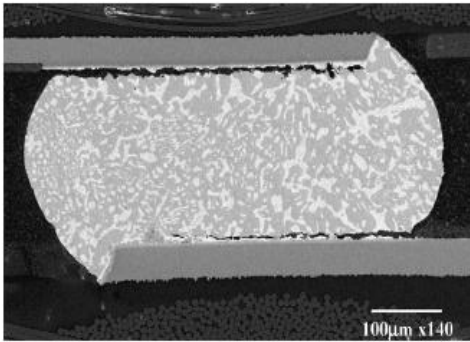
Figure 1: Crack Propagation at the Top and Bottom of a Solder Joint, 15mm BGA [2].

Solder-joint damage under thermo-mechanical and shock stresses is cumulative, and damage manifests in the form of plastic work and cracks, which propagate till eventual fracture of solder joints [1-4] resulting in FPGA operational failures. An illustration of a fractured solder joint (or bump) under thermo-mechanical stresses is shown in Figure 1. Thermo-mechanical stresses may result from differential expansion under environmental and operational temperature exposure due to coefficient of thermal expansion (CTE) mismatches. Shock loads may be imposed during shipping and normal operation in harsh environments. Even though one or more solder balls (bumps) are cracked, a solder-joint network belonging to a damaged bump might not immediately experience a catastrophic failure. One reason is other solder balls of the BGA package remain intact and tend to keep the package pressed toward the board to maintain electrical contact between the surfaces of cracks [4-6].

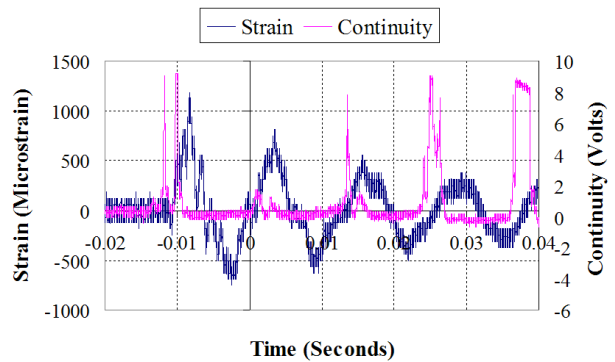
Figure 2: Shock-actuated Failure: Transient Strain and Resistance.

These intermittent faults increase in frequency as evidenced by a practice of logging BGA package failures only after multiple events of high-resistance: an initial event followed by some number (for example, 2 to 10) of additional events within a specified period of time, such as ten percent of the number of cycles of the initial event [8-10]. Even then, an intermittent fault of high-resistance in a solder-joint network might not result in an operational fault. For example, the high-resistance fault might happen in a ground or power connection, or it might happen during a period when the network is not being written, or it might be too short in duration to cause a signal error. Figure 2 shows a shock-actuated intermittent open (high resistance) of a package interconnect.

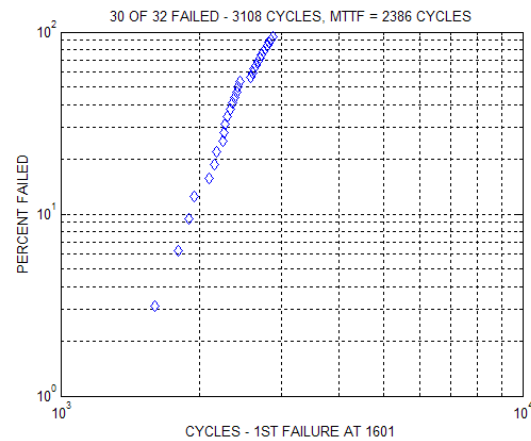
Figure 3: Representation of XILINX FPGA HALT Test Results [9].

Figure 3 represents HALT test results performed on XILINX FG1156 Daisy Chain packages in which 30 out of 32 tested packages failed in a test period consisting of 3108 cycles. Each temperature cycle of the HALT was a transition from -55°C to 125 °C in 30 minutes: 3-minute ramps and 12-minute dwells. What is not immediately apparent is that each of the logged FPGA failures (diamond symbols) represents at least 30 events of high resistance: a FAIL was defined as being at least 2 OPENS (net resistance of 500Ω or higher) within one temperature cycle, log 15 FAILURES [9]. A single fault in a temperature cycle was not counted as a FAIL event.

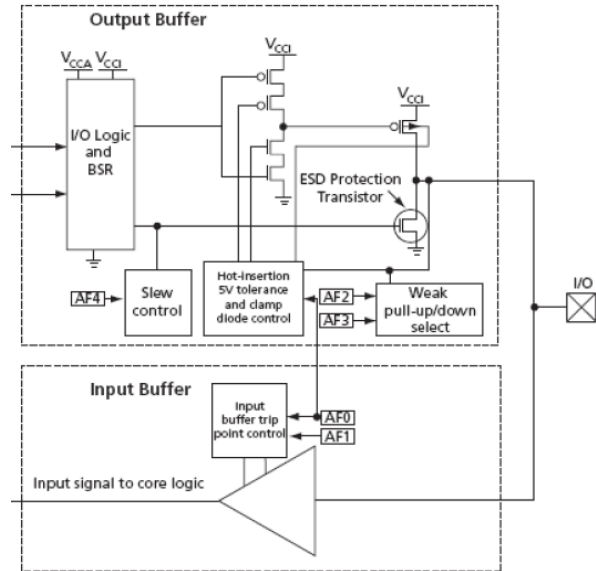
Figure 4: Example of an FPGA I/O Buffer [16].

Prior to this innovation, there were no known methods for detecting faults in operational, fully-programmed FPGAs. Furthermore, FPGAs are not amenable to the measurement techniques typically used in manufacturing reliability tests such as Highly Accelerated Life Tests (HALTs) [4]. This is because those measurement techniques require devices to be powered-off, and because FPGA I/O ports are digital, rather than analog, circuits, an example of which is shown in Figure 4.

Figure 8 shows the signal when the network resistance was increased from 1.0 to $100\ \Omega$. Referring to the first positive pulse of the output, the capacitor is charged through a first I/O port during a first clock and the voltage across the capacitor is read through a second I/O port during a second clock. Because of the increase in the network resistance, the charged voltage across the capacitor is about 2.0V instead of 3.3V and less than 2.0V at the output of the input buffer connected to the second I/O port (see Figure 4), this is logical '0' instead of a logical '1' – this is a fault and the SJ BIST detects it.

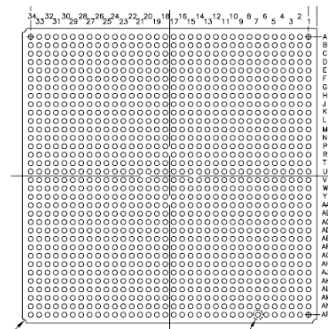
Figure 5: Bottom View of a XILINX FG1156 – Package Size is 35 x 35 mm with a 34 x 34 Array of Solder Balls of Nominal Diameter of 0.6 mm and a Pitch of 1.0mm [17].

Modern BGA FPGAs, such as the fine-pitch XILINX FG1156, have more than a thousand I/O ports and very small pitch and ball sizes. For example, the FG1156 has a 34 x 34 array of nominal 0.60 mm solder balls with a pitch of 1.0mm (see Figure 5). This tends to make physical inspection techniques impractical and not useful.

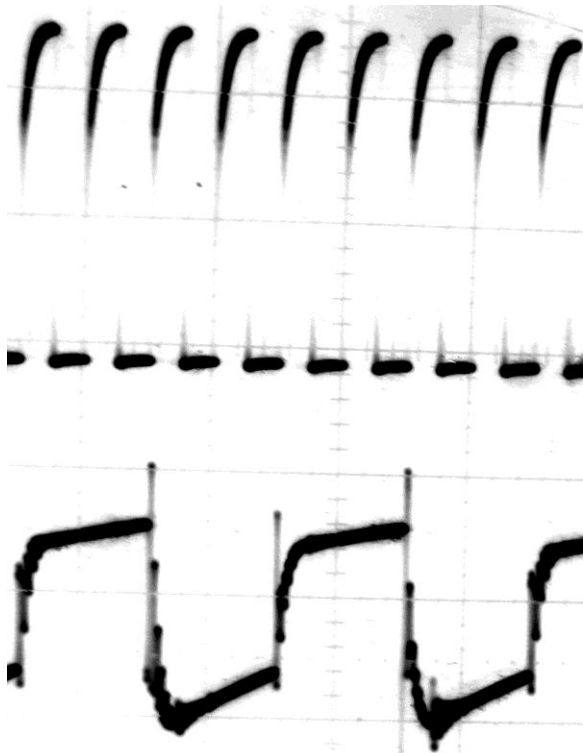
Figure 6: Solder Joint BIST – Input Clock (top) and Signal Across the Capacitor (bottom): $2\mu\text{s} \times 2.0\text{V}$ Grid.

Referring to Figure 6, the top picture is a 1.0 MHz clock input to a test FPGA and the bottom is the signal across a 1.0 μF capacitor connected to two I/O ports selected for testing. The signal across the capacitor is caused by the SJ BIST writing '1s' and '0s.'

Still referring to Figure 6, the positive pulse of the first clock causes the Solder Joint Built-In Self-Test (configured for a two-port BIST) to write a logical one ('1') through the first I/O port to the capacitor. The charged voltage on the capacitor is read from the second I/O port during the positive pulse of the second clock. For this test, a one (3.3V) is both written and read, so the SJ BIST then writes a logical zero ('0') during the third clock through the first I/O port to the capacitor to discharge it. During the 4th clock, the charged voltage is read from the second I/O port. For this case, because a '0' was both written and read – the first I/O port is evaluated as being okay and no fault is reported.

During the next set of four clock periods, the SJ BIST writes through the second I/O port instead of the first I/O port; the SJ BIST reads from the first I/O port instead of the second I/O port.

Referring back to Figure 6, the signal sequence is write-read '1' (test I/O port 1), write-read '0' (test I/O port 1), write-read '1' (test I/O port 2) and write-read '0' (test I/O port 2). This sequence takes a total of 8 clocks to complete. This means the following: (1) a fault must have a minimum duration of 4 clock periods for "guaranteed" detection; (2) a fault with a duration of one-half of a clock period is detectable when it occurs at the start of either the write-read '1' or the write-read '0' sequence for that pin. For a FPGA with a 100MHz CLK, the guaranteed detection duration is 40 ns.

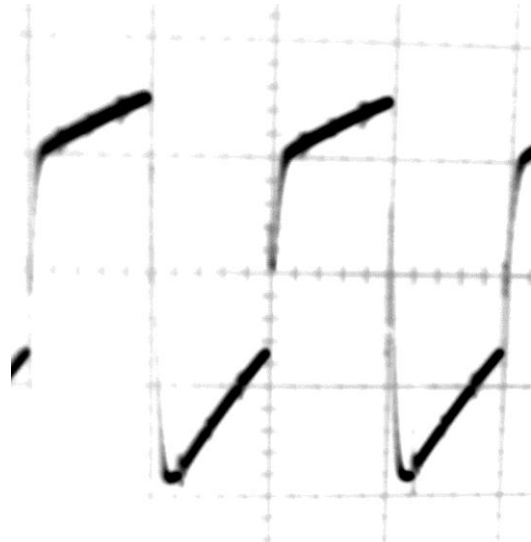
Figure 7: Signal Across a 100 nF Capacitor Attached to a Solder Joint with a Network Resistance of $1.0\ \Omega$: $2\mu\text{s} \times 1.0\text{V}$ Grid.

The $1\mu\text{F}$ capacitor was then replaced by a 100 nF capacitor, which in turn was connected to the FPGA I/O port via network wiring having a resistance of $1.0\ \Omega$ – higher than the total $100\text{ m}\Omega$ resistance we expect as the maximum resistance of a solder ball and the network to which it is

attached. Figure 7 shows the resulting signal, which, as expected, did not cause the SJ BIST to detect a fault.

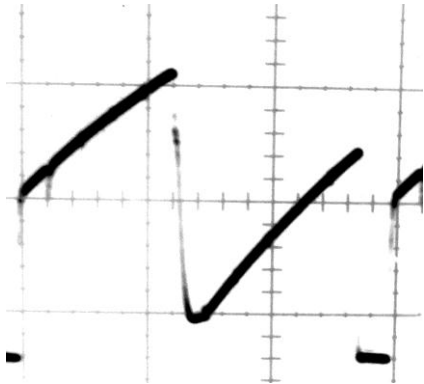
Figure 8: Signal Across Capacitor – Network Resistance Increased from 1.0 to 100 Ω : 2 μ s x 1.0V Grid.

Still referring to Figure 8, in a third clock period, the fault is recorded by incrementing a fault counter for that I/O port and a '0' is written through that first I/O port – but as seen, the capacitor does not fully discharge, which is another fault condition. In the next three clocks, the second fault is detected, evaluated and then a '0' is written – through the second I/O port instead of the first. As seen, the second write '0' is successful – the capacitor is fully discharged. The second fault condition is evaluated by the SJ BIST as being a continuation of the previously detected fault and it is not recorded as new fault – a fault

counter is not incremented. Had the most previous write-read of '1' been successful, this write-read of '0' would have been recorded as a new fault.
