# INTERMITTENCY DETECTION AND MITIGATION IN BALL GRID ARRAY (BGA) PACKAGES

**Abstract – An update on a method (SJ BIST™) to detect intermittencies in Ball Grid Array (BGA) packages is presented, and another method (SJ Monitor™) is introduced. SJ BIST™ is primarily firmware embedded in the FPGA application; SJ Monitor™ is hardware on an IC chip.**

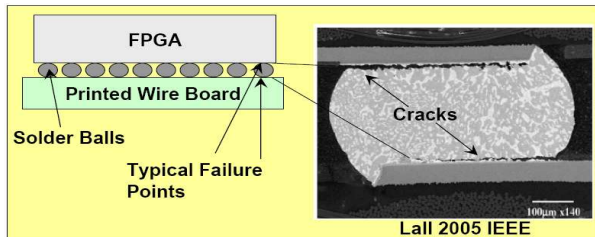
**Figure 1: Crack Propagation at the Top and Bottom of a Solder Ball, 15 mm BGA [3].**

Solder-joint damage under thermo-mechanical and shock stresses is cumulative and is manifested as plastic work leading to voids and cracks, as seen in Figure 1; cracks propagate to become fractures [2-5] which cause FPGA operational faults. Thermo-mechanical stresses

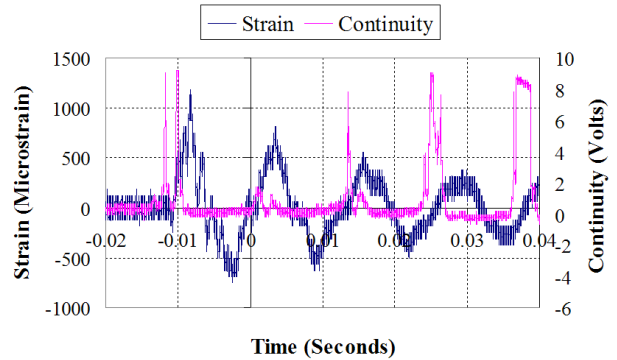
**Figure 2: Shock-actuated Failure: Transient Strain (Blue) and Intermittent Opens (Mauve).**

These intermittent faults increase in frequency as evidenced by a practice of logging BGA package failures only after multiple events of high-resistance: an initial event followed by some number (for example, 2 to 10) of additional events within a specified period of time, such as ten percent of the number of cycles of the initial event [9-11]. Even then, an intermittent fault in a solder-joint network might not result in an operational fault. For example, the fault might be in a ground or power connection; or it might occur during a period when the network is not being written; or it might be too short in duration to cause a signal error. Figure 2 shows shock-actuated intermittent faults in a package interconnect: the duration of the fault during the 5<sup>th</sup> cycle is over 3 milliseconds.

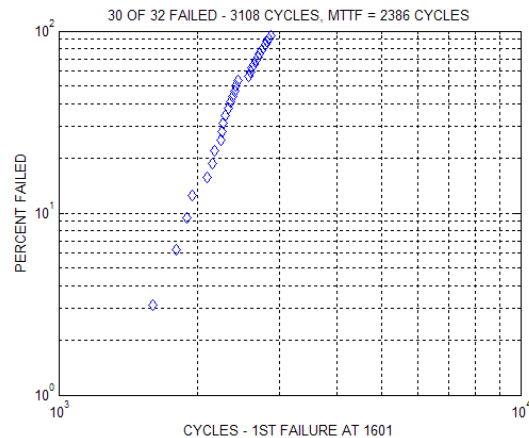
**Figure 3: Representation of XILINX FPGA HALT Test Results [9].**

Figure 3 represents HALT test results performed on XILINX FG1156 Daisy Chain packages in which 30 out of 32 tested packages failed in a test period consisting of 3108 HALT cycles. Each temperature cycle of the HALT was a transition from -55°C to 125 °C in 30 minutes: 3-minute ramps and 12-minute dwells. What is not immediately apparent is that each of the logged FPGA failures (diamond symbols) represents at least 30 events of high resistance: a FAIL was defined as being at least 2 OPENS (net resistance of 500 Ω or higher) within one temperature cycle, log the package as failed after 15 FAILS [10]. A single OPEN in any temperature cycle was not counted as a FAIL event.

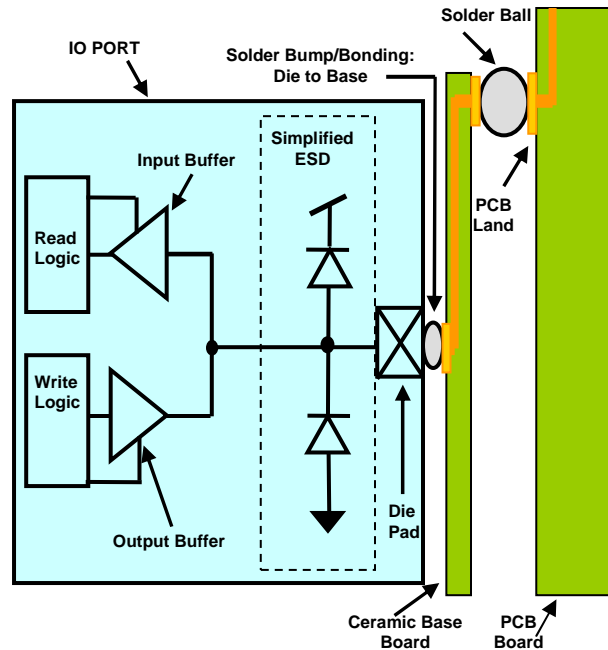
Figure 4: FPGA Diagram, I/O Buffer [17,18].

These sensor methods are the first known for detecting faults in solder-joint networks of I/O ports of operational, fully-programmed FPGAs. Furthermore, FPGAs are not amenable to the measurement techniques typically used in manufacturing reliability tests such as Highly Accelerated Life Tests (HALTs) [5]. This is because, for example, a 4-point probe measurement requires devices to be powered-off; and because FPGA I/O ports are digital, rather than analog, circuits (see Figure 4).

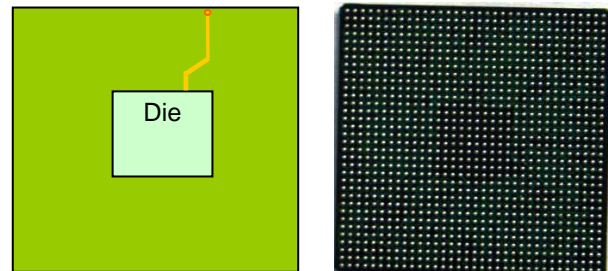
Figure 5: XILINX FG1156: Size is 35x35 mm<sup>2</sup>; Pitch: 1.0 mm. Ball: 0.6 mm [17,18].

Modern BGA FPGAs have more than a thousand pins and very small pitch and ball sizes, for example, Figure 5 shows the bottom of a XILINX FG1156 with a footprint of 35x35 mm<sup>2</sup>, and an array of 34x34 solder balls.

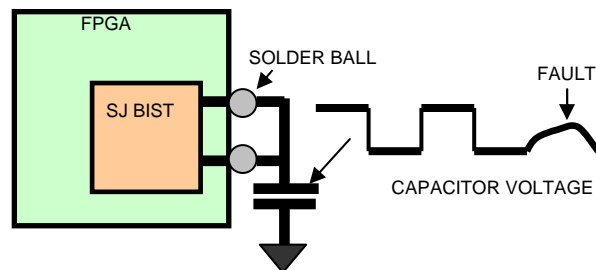
Figure 6: SJ BIST Block Diagram

SJ BIST requires the attachment of a small capacitor to an unused I/O port as near as possible to a corner of the package. Figure 6 is a block diagram of an FPGA containing SJ BIST with a capacitor connected to two I/O pins.

Referring to Figure 6, SJ BIST writes a logical '1' to charge the capacitor and then reads the voltage across the charged capacitor. If the solder-joint network of the I/O port of the FPGA is undamaged, the write causes the capacitor to be fully charged and a logical '1' is read by SJ BIST. When the solder-joint network is damaged, the effective resistance of the SJ network increases, the charging time constant increases, the write fails to sufficiently charge the capacitor, and a logical '0' instead of a logical '1' is read: a fault occurs, is detected by SJ BIST and is reported.

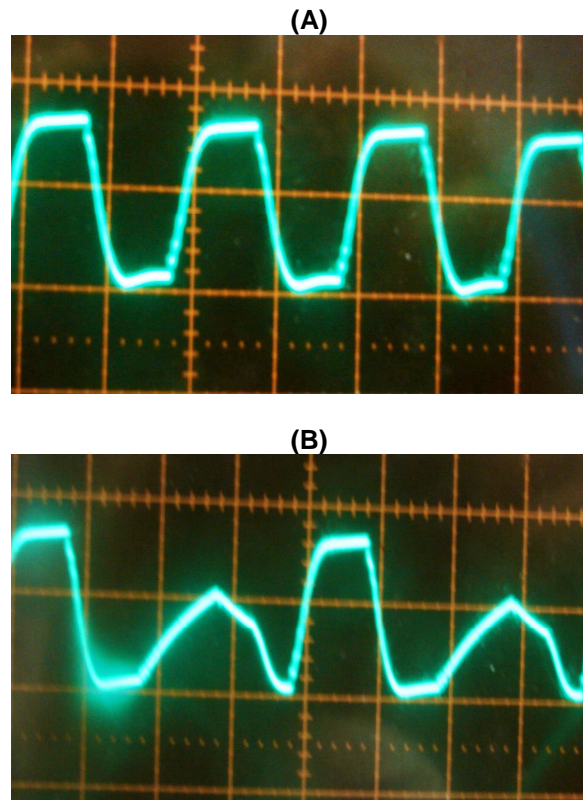
Figure 7: SJ BIST: 1 MHz Capacitor Signal. Top is for a No Fault Condition; Bottom is for a Fault Condition (100  $\Omega$ ) – 0.5  $\mu$ s x 2.0V Grid.

Referring to Figure 7, two sets of voltages on a 1.0  $\mu$ F capacitor connected to a group of two I/O ports are shown. Figure 7A shows the capacitor voltage when one of the two ports connected to the capacitor has a 1  $\Omega$  resistor connected in series with the solder joint: the resistance is not high enough cause a write fault to occur, and SJ BIST correctly did not report a detected fault.

Figure 7B shows the capacitor voltage when the resistance is increased to 100  $\Omega$ , a write fault occurs. SJ BIST correctly reported the fault and incremented the fault count for that I/O pin.

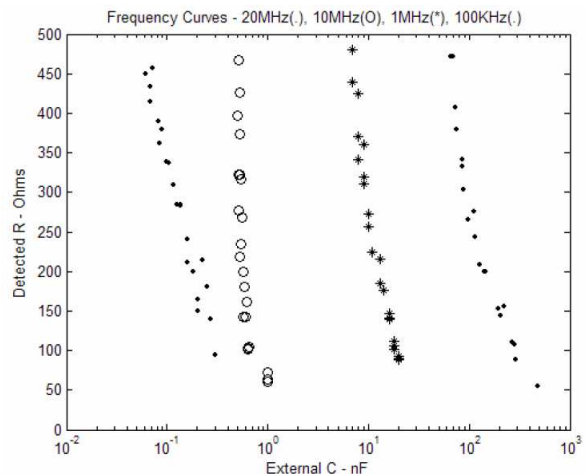
Figure 8: Clock Frequency, External Capacitor Value and Detectable Fault Resistance – Sep. 2006.

There is a relationship between the frequency of the FPGA clock, the value of the connected capacitor to each group of two I/O pins, and the detectable fault resistance. Figure 8 shows the results of tests conducted in September of 2006: For a given clock frequency, there is a capacitor value that will cause SJ BIST to always detect a fault resistance at least as low as 100  $\Omega$ .

Figure 17 shows a test result using a known fault of 300  $\Omega$ , a 25 MHz clock and a 47 pF capacitor. The result is actually better than that predicted by Figure 8: for a 300  $\Omega$  fault, a 20 MHz clock and a 100 pF capacitor.

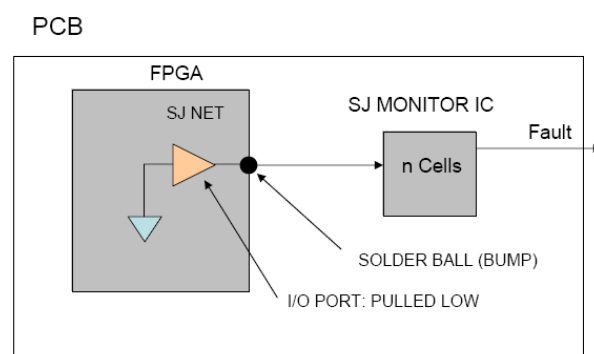
**Figure 9: SJ Monitor Block Diagram**

SJ Monitor is designed and is being developed as an Integrated Circuit (IC) chip, which must be mounted next to and connected to the FPGA on the board. SJ Monitor is a low-power, continuous monitoring sensor: at 1.2 V to 2.5 V, it uses less than 5.0 mW to monitor 8 I/O pins. SJ BIST has a power requirement of over 100 mW to test 8 I/O pins. A block diagram representation of SJ Monitor is shown in Figure 9.

Although an active I/O port is shown in Figure 9, an active port is not a requirement: the only requirement is the port must be at logical zero level.

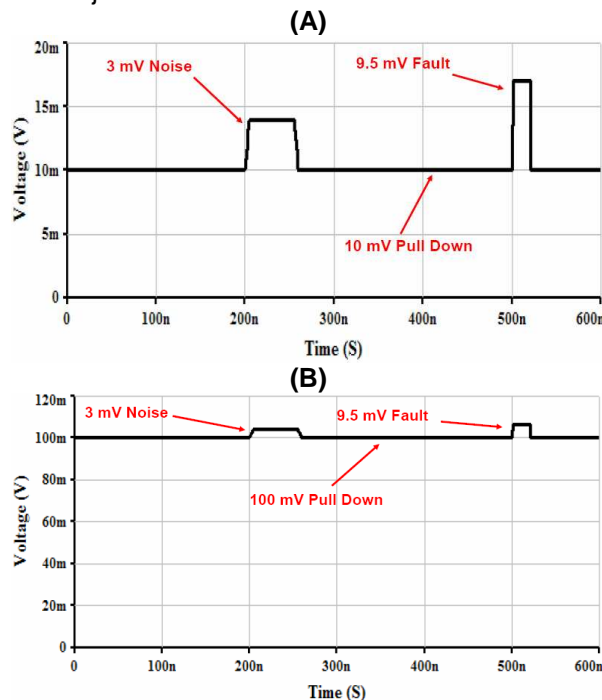
**Figure 10: FPGA I/O Pin Voltages: (A) Pull-down is 10 mV and (B) Pull-down is 100 mV; Noise is 3.0 mV, Fault Perturbation is 19.5 mV.**

Referring to Figure 10, (A) shows an I/O pin with a pull-down voltage level of 10 mV and (B) shows an I/O pin with a pull-down voltage level of 100 mV. Superimposed on each of the pull-down voltage levels are 3.0 mV noise pulses and 9.5 mV fault perturbations. The fault perturbations are caused by injecting a 100  $\Omega$  fault into the solder-joint network.

SJ Monitor is insensitive to a specific value of pull-down voltage: Both of the input conditions seen in Figure 10 result in the output shown in Figure 11. SJ Monitor uses signal conditioning to ignore the pull-down voltage level, to suppress noise and to amplify the fault perturbation to produce a digital fault signal.

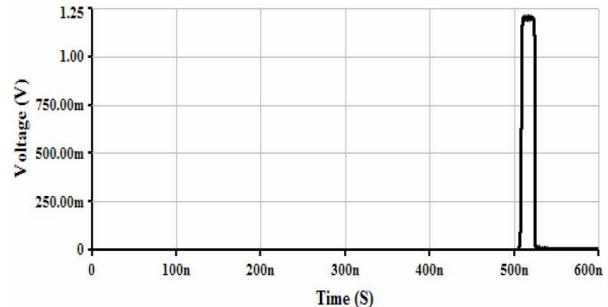
**Figure 11: SJ Monitor Fault Signal Response to Figure 10 A and B.**

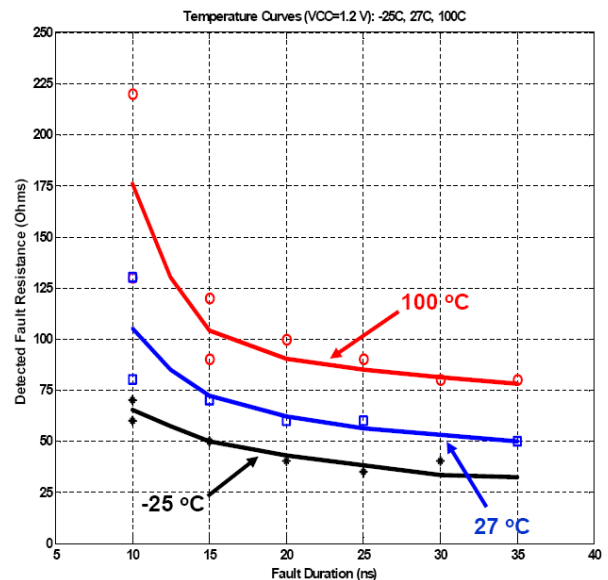
**Figure 12: Temperature, Fault Resistance and Fault Duration Curves.**

The value of the minimum detectable fault resistance is primarily dependent on the duration of the fault and the operating temperature as shown in Figure 12. The results indicate that SJ Monitor is able to detect a fault resistance at least as low as 100  $\Omega$  when the fault duration is at least as long as 20 ns.

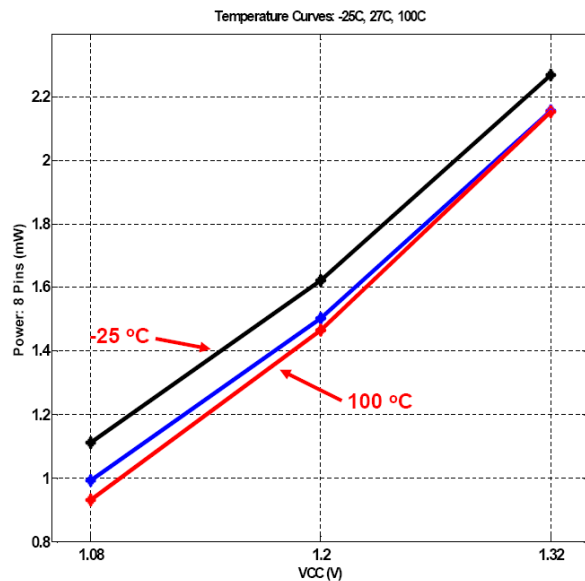
Figure 13: Power Used vs Temperature and Supply Voltage (VCC).

Test simulations showed SJ Monitor has a power requirement of between 0.9 mW and 2.4 mW to monitor 8 I/O pins, depending on temperature and voltage. This low power requirement makes SJ Monitor suitable for continuous monitoring and for short test applications.

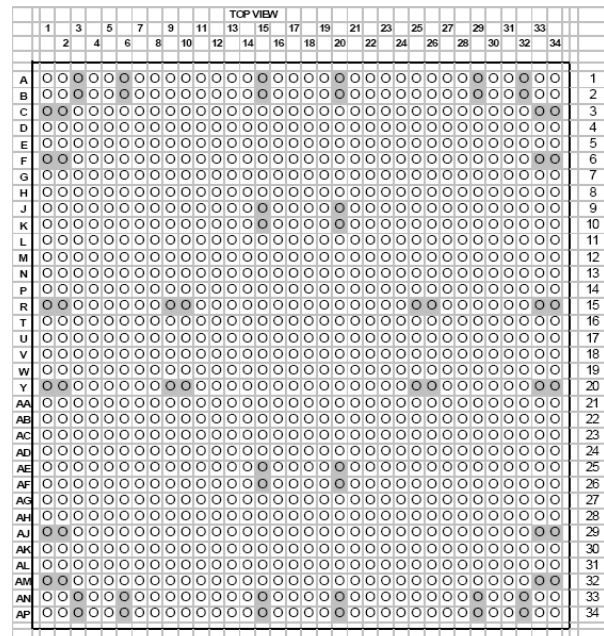
Figure 14: FG1156 Footprint Showing Selected SJ BIST I/O Pins: 32 Groups, 64 Pins.

Figure 14 is a footprint for a XILINX FG1156 FPGA showing the I/O pins (shaded) we selected for testing by SJ BIST. Sixty-four I/O pins were selected, so there are 32 groups of SJ BIST cores in our test program.

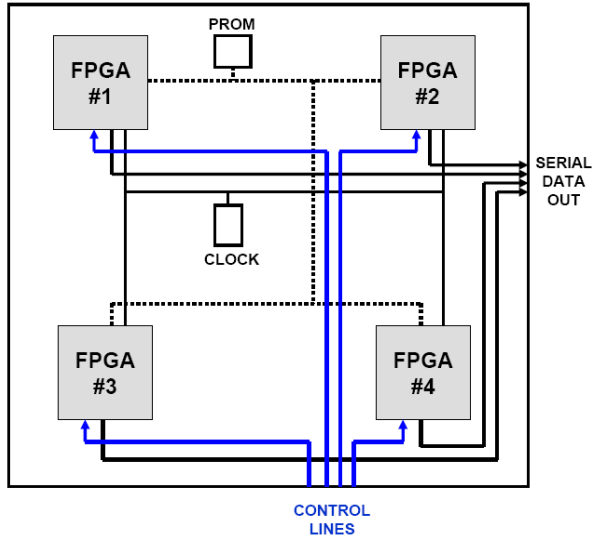
Figure 15: HALT Test Board Block Diagram.

Figure 15 is a block diagram of the HALT test board we designed. We load the SJ BIST test program into a PROM, which then loads the program into each FPGA when the board is powered on. Each FPGA generates 640 bits of data (64 x (2 faults signals + 8 bits of count)); each board generates 2560 bits of data, and we have 4 boards in the HALT oven = 10,240 bits of data for each sample period. We wrote a LabVIEW® program to control the collection of data, and we wrote a MATLAB® program to process the data.

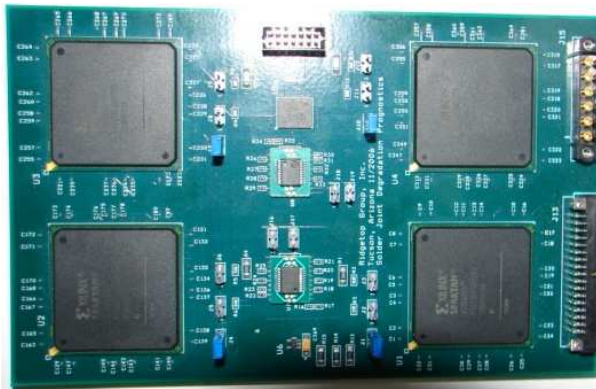
Figure 16: HALT Experiment Board with Four XILINX FG1156 FPGAs.

Figure 16 shows a manufactured, populated and soldered HALT test board. There are three connectors: (1) XILINX programmer connection, (2) power input and (3) experiment control connections.

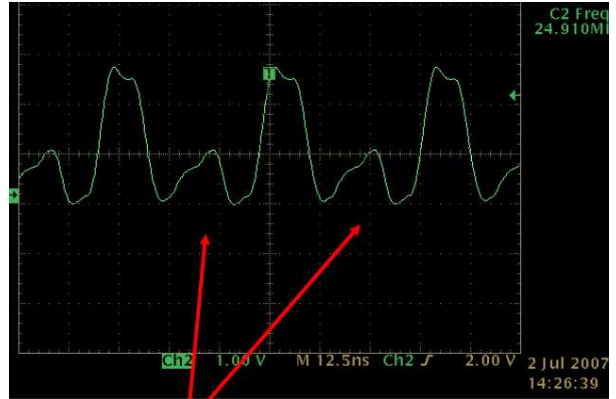
300 Ohm Fault  
Figure 17: 25 MHz CLK, 47 pF, 300  $\Omega$  Test.

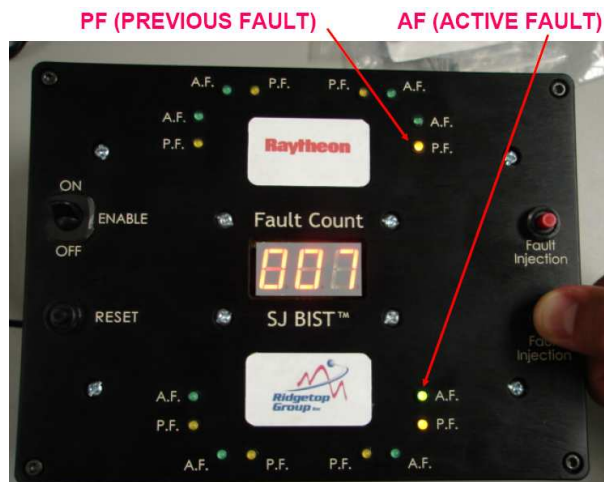
Figure 18: SJ BIST Demonstration Box.

**Error! Reference source not found.** is a picture of one of the SJ BIST demonstration boxes being tested for delivery to Raytheon Missile Systems. The front panel shows a fault count of 7, a previously detected fault in an upper-right pin, and both an active (the fault inject button is depressed) and a previously detected fault in a lower-right pin. The purpose of the box is to allow for portable demonstrations, and to allow non-Ridgetop personnel to independently demonstrate and evaluate SJ BIST.

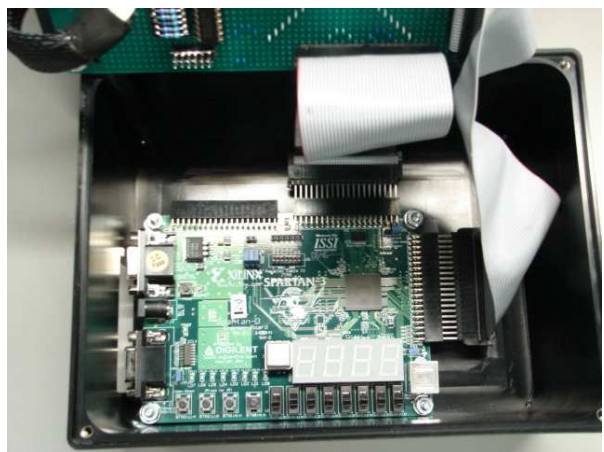
Figure 19: SJ BIST Demonstration Box, XILINX Spartan 3 Board.

Figure 19 is a picture of the XILINX SPARTAN@-3 board inside of the SJ demonstration box. We programmed the FPGA to monitor 8 I/O pins.

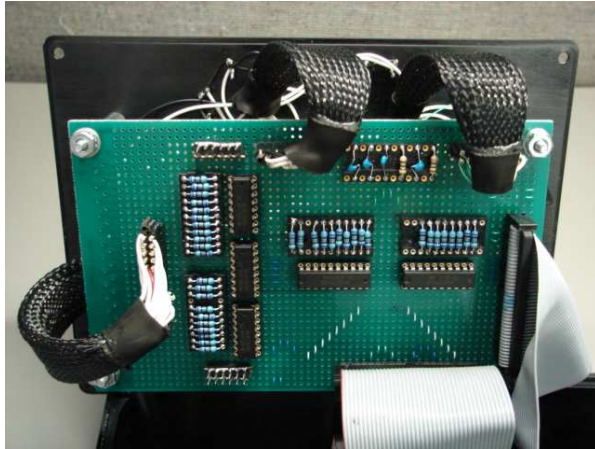
**Figure 20: SJ BIST Demonstration Box, Display Board.**

Figure 20 is a picture of the display control board for the SJ BIST demonstration board. The board provides the interface and control between the box front panel and the FPGA. Not shown is a small board upon which the 7-segment LED is mounted. Future versions of the SJ BIST demonstration box will use a printed circuit board instead of a bread board.
